# Experimental evaluation of the performance of earth levees deteriorated by wildlife activities

**Abstract** In this study, an earth levee model is constructed to investigate the impact of animal burrows on the integrity and performance of earthen structures. A series of centrifuge experiments are conducted on homogenous scaled-down 1H:1V levee models built from the natural Kasama soil. Both intact and deteriorated models were subject to a 35g acceleration level. Invasive animal intrusions were introduced in the form of horizontal array of idealized cylindrical burrows at the mid-height of the levee. The water level was gradually increased during the centrifuge flight, and the response of the levee was monitored throughout the test. Pore pressures were recorded using pressure transducers placed at preselected locations within the model. Surface displacements were measured using laser LVDTs and supplemented with three digital cameras for tracking the overall deformation pattern of the levee model. A summary of the test procedure and selected results is presented herewith. The observed deformation mechanism due to the presence of animal burrows is also described. As compared with t

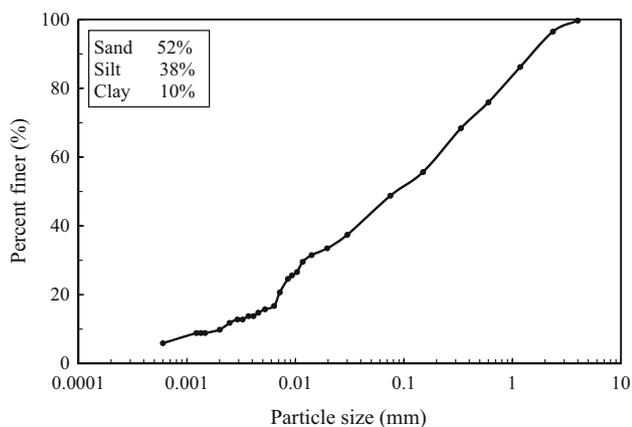
**Fig. 1** Grain size distribution of Kasama soil

Previous studies showed that burrowing animals tend to smartly dig in relatively loose soils that exhibit some cohesion. These favorable geologic conditions ensure efficient excavation while maintaining stability of burrows [14]. The natural Kasama soil, successfully used in similar centrifuge experiments [13], was utilized in this study to mimic these favorable conditions. Kasama soil gradation has been determined based on ASTM D6913 [15] and ASTM D422 [14] (Fig. 1). The soil is classified as silty sand (SM) based on the USCS classification system, with 52 % sand, 38 % silt, and 10 % clay content. A summary of the basic soil properties is given in Table 2. Figure 2 shows the standard proctor results used to determine the maximum dry density of the soil based on ASTM D698 [16].

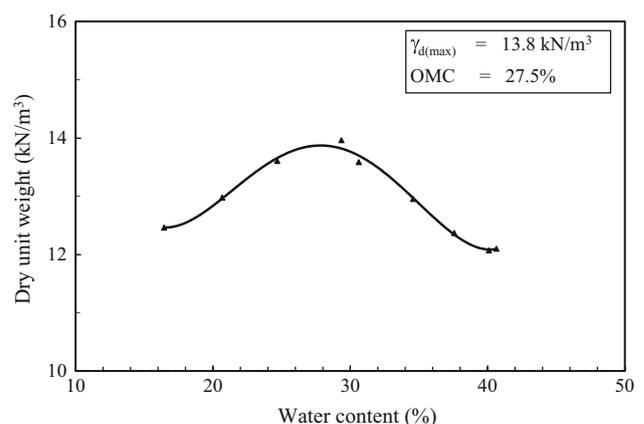
**Fig. 2** Standard proctor test on Kasama soil

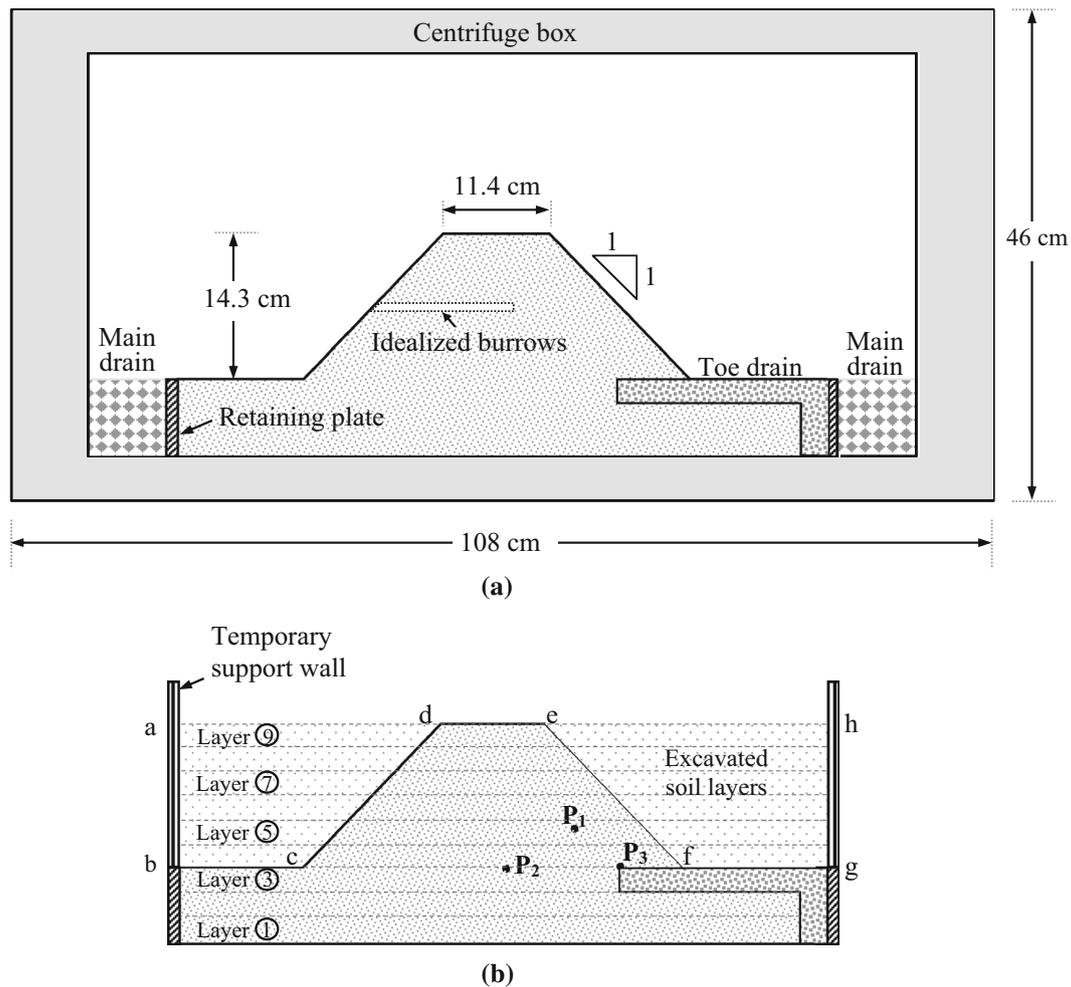
**Fig. 3** Model configurations: **a** geometry; **b** construction procedure and location of pore pressure transducers ( $P_1$  through  $P_3$ )

The geometrical configurations were selected based on the common height of the reported levee failures due to animal burrows [17]. The 1:35 scaled-down section was built to model a 5-m high-levee cross section with a 4-m wide crest width and the selected 1H:1V side slopes. As shown in Fig. 3a, the levee model has a landside toe drain to keep the slope dry and reduce the number of parameters affecting the slope stability of the intact levee. Both intact and deteriorated models were constructed following the same procedure and tested under similar conditions.

of the soil in equal thickness lifts (layers) up to the desired height and (2) removal of the soil (excavation) in order to shape the levee cross section (Fig. 3b). The desired levee profile was overlain on the glass walls of the centrifuge box before soil placement (points  $b$  through  $g$ ). The levee is constructed in nine 2.5-cm thick lifts. Each soil layer is compacted at a moisture content of approximately 30 % using a 57 kN handheld vibratory compactor with plate dimensions of 12 cm in width and 15 cm in length that weighs approximately 57 kN. The toe drain material is placed within the bottom three layers using vertical and horizontal spacers. Upon placing the first two layers (Fig. 3b), the vertical part of the granular toe drain is placed and compacted. The 100 psi (689.5 kPa) miniature pore pressure transducers (PPT) with thin cables (Model GE Druck PDCR 81-347) are placed within the model at preselected locations to monitor the pore pressure changes during the test (Fig. 3b). The use of sufficiently long PPT wires minimizes the impact of wiring interference on the measured deformations. Core samples were collected from both the waterside and landside—away from the levee section—to verify the degree of compaction and the water content before excavation. A total of eight soil samples were extracted from the levee model using a thin-walled

tube sampler of 2.25 cm in diameter. Following the placement of the top layer (layer 9 in Fig. 3b), the excavation process was carried out from the waterside and landside (lines ab and gh) toward the predefined faces (lines cd and ef) of the levee cross section. This necessitated the removal of the soil volume within two trapezoidal areas: abcd and efgh. Excavation is performed slowly in order to minimize disturbance of the levee model. The model profile (points b through g) is continuously monitored during the construction and instrumentation stages. The foregoing scheme was adopted to build both of the intact and deteriorated levee models.

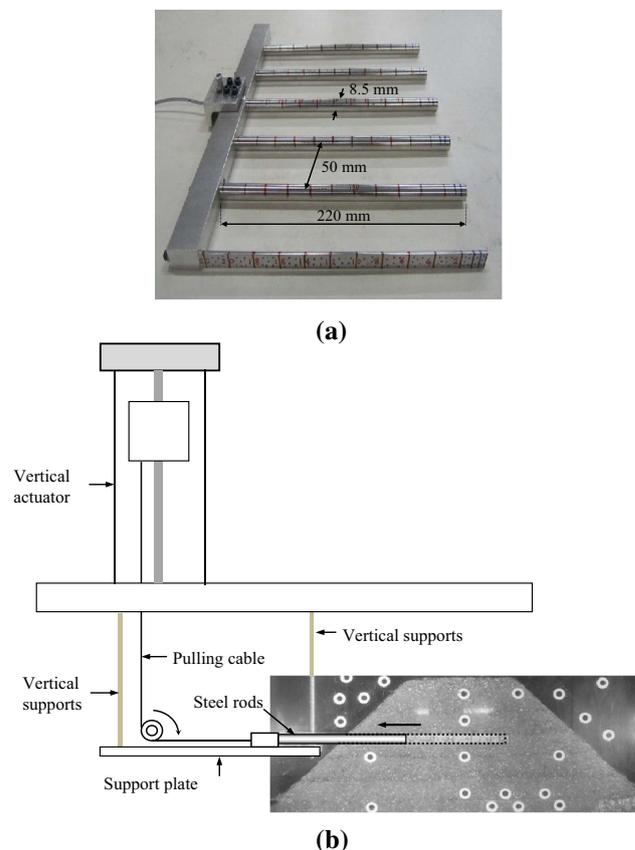
**Fig. 4** Burrow modeling technique: **a** rod set; **b** pullout system

Burrows were introduced into the built model by initially placing a set of rods, comprised of six 8.5-mm prismatic cylindrical stainless steel rods, at the mid-height of the levee section. The rods are of the same length and spaced 50 mm apart in plan as shown in Fig. 4a. At 35g, the chosen 8.5-mm cavity diameter approximately resembles 300-mm-diameter burrows which is consistent with the size of common wildlife intrusions [2]. The preinstalled rods placed within the model were removed during centrifuge flight using a specially designed pullout system as shown in Fig. 4b. This system consists of a linear actuator, a pulling

cable running over a fixed pulley, and vertical and horizontal support plates (Fig. 4b). The friction along the rod–soil interface was minimized by precise machining and smoothing of the rod surfaces. The rods were marked at preselected equal intervals for tracking of the buried length using a monitoring system installed around the model. Upon reaching the target  $g$ -level (35g), the pullout of the rods array triggered. This technique ensures smooth sliding of the connection beam on the support plate until the rods were completely removed from the model.

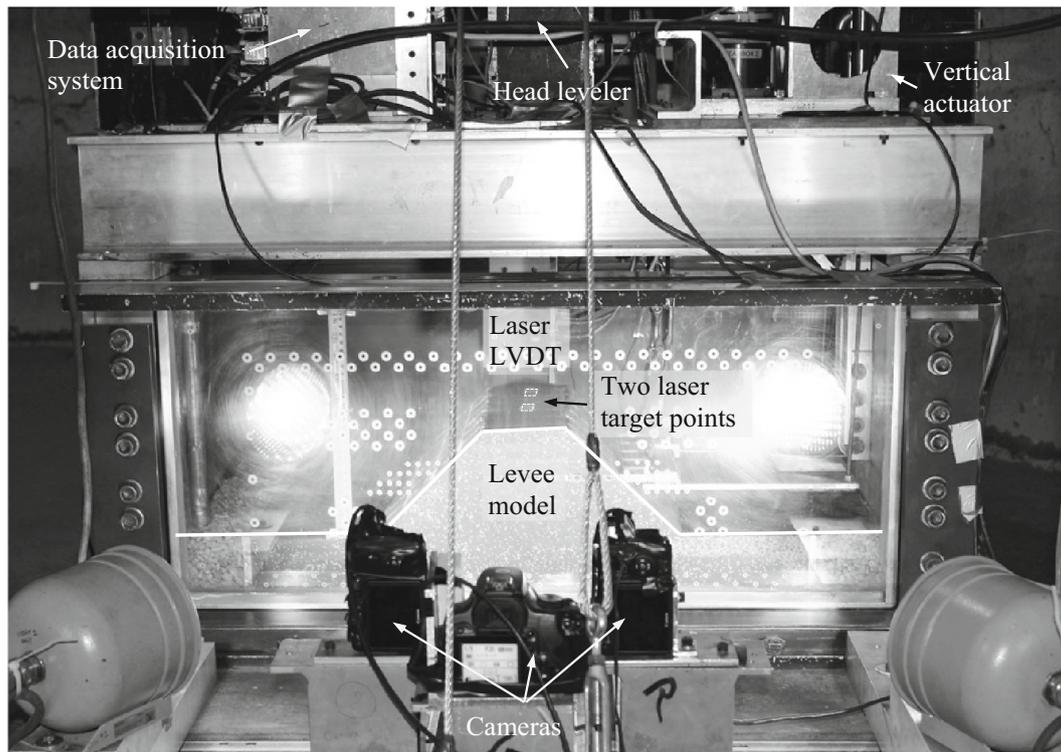
**Fig. 5** Test setup and monitoring system installed on the centrifuge basket

Three high-resolution digital cameras (10.0 MP, 6× optical zoom) were placed outside the box to monitor the deformation field of the soil particles during the experiment. Still shots are taken every 5 s throughout the experiment. In addition, the top surface of the model, marked with white paint, is continuously monitored using HD camcorder. Crest settlement has been measured during the tests using two laser LVDTs attached to the box pointing down toward the levee surface. The test setup and monitoring system are illustrated in Fig. 5.

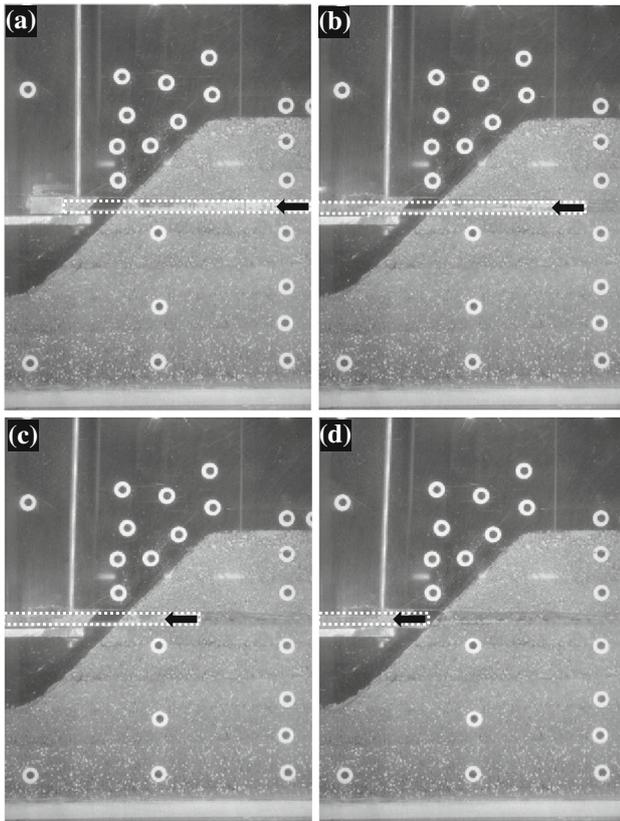
**Fig. 6** Rod set pullout process: **a** initial; **b** half way; **c** three quarters; **d** complete removal

Figure 6 shows a set of successive images that illustrate the rod removal process as captured by the cameras facing the model. It is crucial to ensure burrow stability before the water level was raised. Therefore, the vertical displacements (settlement) of the levee crest are closely monitored using two laser sensors directed toward the crest during the pullout process. The measured crest settlement versus elapsed time of the centrifuge spin is depicted in Fig. 7. The rods pullout was performed between approximate elapsed times ( $t$ ) of 2,300–3,000 s marked by stages C and D, respectively (Fig. 7). Insignificant settlements were noted during the removal of the rod system. Thus, the cavities introduction and pullout technique seem to provide repeatable initial conditions with a minimal effect on the levee integrity. By inspecting the measured crest settlement of the levee model to up to an elapsed time of 5,000 s, it is evident that the levee started to experience rapid increase in settlement shortly after the water level was raised (at approximate elapsed time of 4,000 s as depicted in Fig. 7).

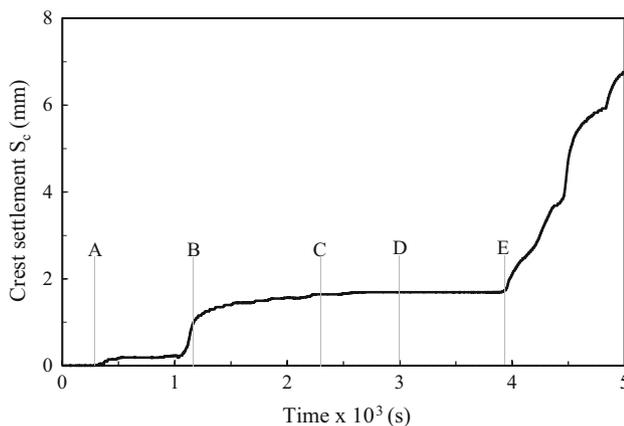
**Fig. 7** Progress of crest settlement during a typical centrifuge flight: **A** spin-up; **B** 35g; **C** beginning of pullout; **D** end of pullout; **E** increase WL

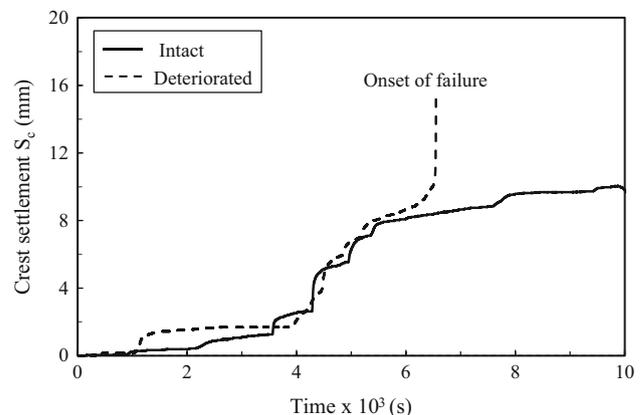
**Fig. 8** Crest settlement of intact and deteriorated levees

The crest settlement of the intact and deteriorated levee models are shown in Fig. 8. Crest settlement and levee

distortion were closely monitored during testing. For both configurations, the crest experienced a small increase in settlement of about 2 mm prior to the commencement of water ( $t \cong 4,000$  s). The rate of settlement rapidly increased in both cases to about 8 mm shortly afterward ( $t \cong 6,000$  s). This is attributed to the water flow through the levee and the associated increase in pore pressure within the body of the levee and its foundation. Beyond that point, the two configurations exhibit quite distinguishing responses. The crest settlement of the intact levee (indicated by the solid line) stabilizes at about 9 mm, whereas the deteriorated levee (the broken line) experienced excessive settlement (the near vertical line) followed by a rapid failure.

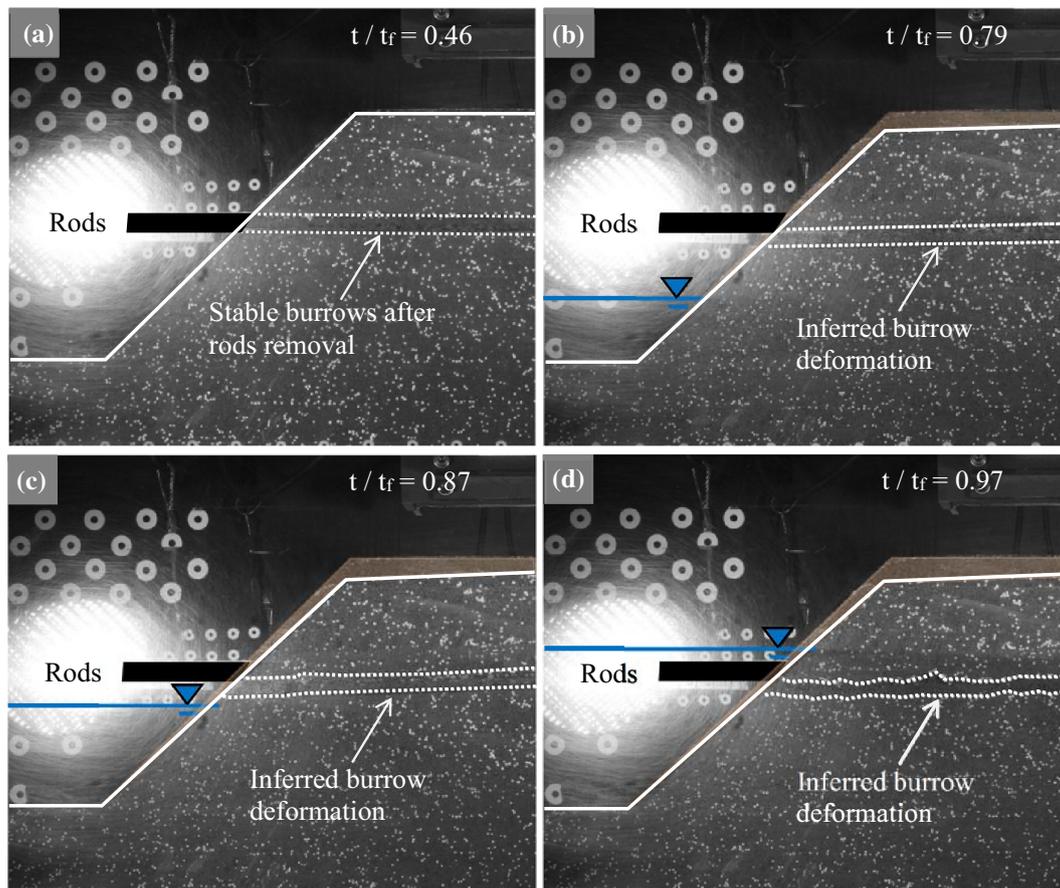
**Fig. 9** Observed crest settlement and traced deformation of burrows: **a** immediately after rod removal; **b** water flow reaches burrows level; **c** upstream water filled the burrows; **d** water level higher than burrows elevation

Selected snapshots of the levee cross section were taken at different elapsed times to examine the progression of geometrical changes to the original profile and the burrows following the increase in water level (Fig. 9). The time elapsed is normalized with respect to the levee failure time ( $t_f$ ). The rod location is indicated in dark color to allow for tracking the movement of the burrows during levee settlement. Figure 9a depicts the changes in the levee cross

section following the rod set removal and right before elevating the water level. Evidently, the levee geometry is essentially unchanged, and the traced burrow geometry remains in line with the rod set location. When the water level reached about 25 % of the levee height (at  $t/t_f \cong 0.79$ ), downward movement of both the crest and the

burrows is observed (Fig. 9b). At  $t/t_f$  of about 0.87, where the water level stand right below the burrow, levee settlement increased and became slightly non-uniform with more settlement near the waterside (Fig. 9c). When the burrows became fully inundated ( $t/t_f \cong 0.97$ ), additional deformation was observed, and the cylindrical shape of the burrow experienced a substantial distortion, creating non-uniform diameter as illustrated in Fig. 9d.

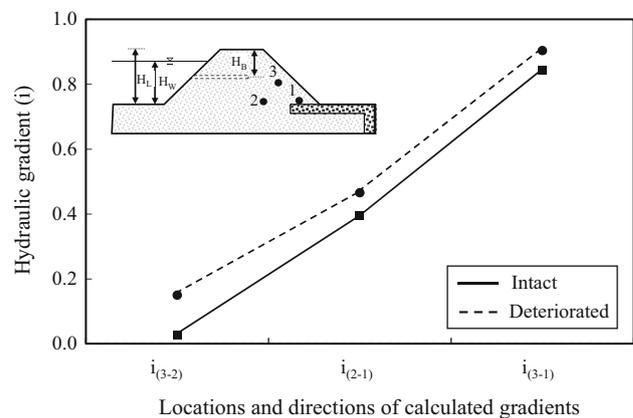
**Fig. 10** Estimated hydraulic gradients near the exit locations

The hydraulic gradient near the exit points was calculated based on the modified head by dividing the difference in total head ( $h_t$ ) by the distance between the two PPTs. Figure 10 shows the changes in hydraulic gradient at the three preselected locations 1, 2, and 3 for both the intact and deteriorated levee. Based on this arbitrary definition, the hydraulic gradient is found to be notably higher for the deteriorated levee compared to the intact case. This was

globally observed with an increasing trend toward the exit slope in the vicinity of the toe drain.

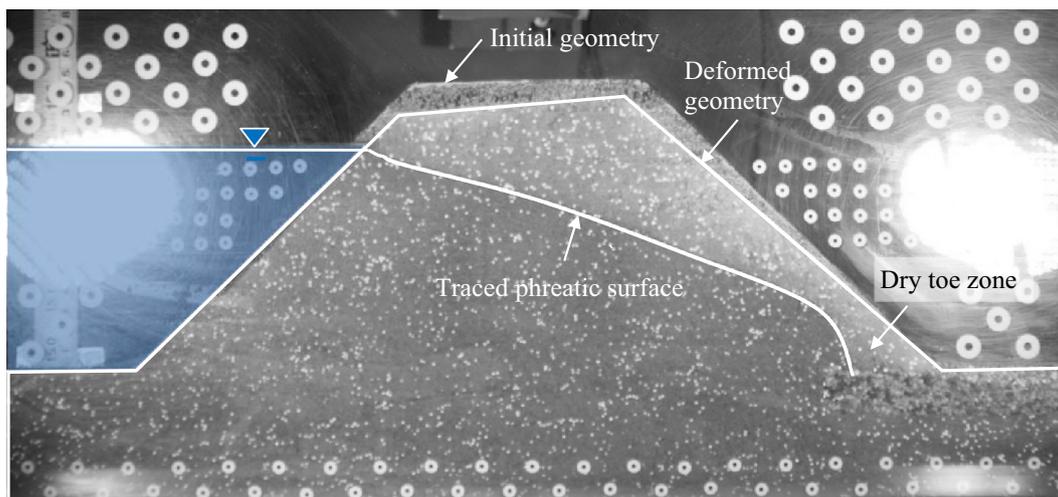
Fig. 11 Observed seepage through the intact levee structure and the inferred phreatic surface

The traced phreatic surfaces for the intact levee are depicted in Fig. 11 at the maximum retained water level. The phreatic surface appears to follow the theoretical pattern with an uninterrupted path ending at the toe drain. The slightly darker shades in Fig. 11 indicate the wet soil mass below the phreatic line. This is not, however, the case for the deteriorated levee as the presence of the water-filled

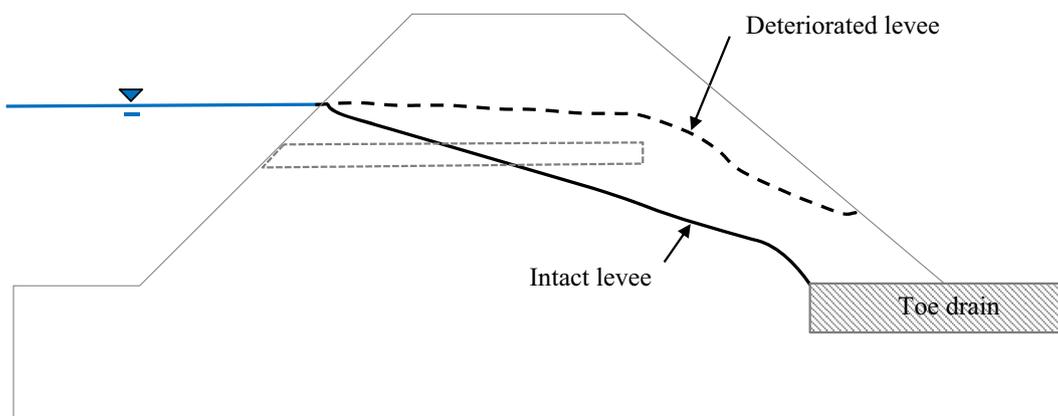
Fig. 12 Conceptual comparison between traced phreatic surfaces for intact and deteriorated levees

cavities appreciably altered the seepage path. The phreatic surfaces for both cases are conceptually illustrated in Fig. 12. For the deteriorated levee, the phreatic surface became essentially horizontal along the burrow length and intersected with the landside slope. In this case, the phreatic surface further advances horizontally leaving a larger wet area above the toe drain with the water flow exiting through the slope. Piping was observed during the experiment immediately before slope failure. Figure 13 shows

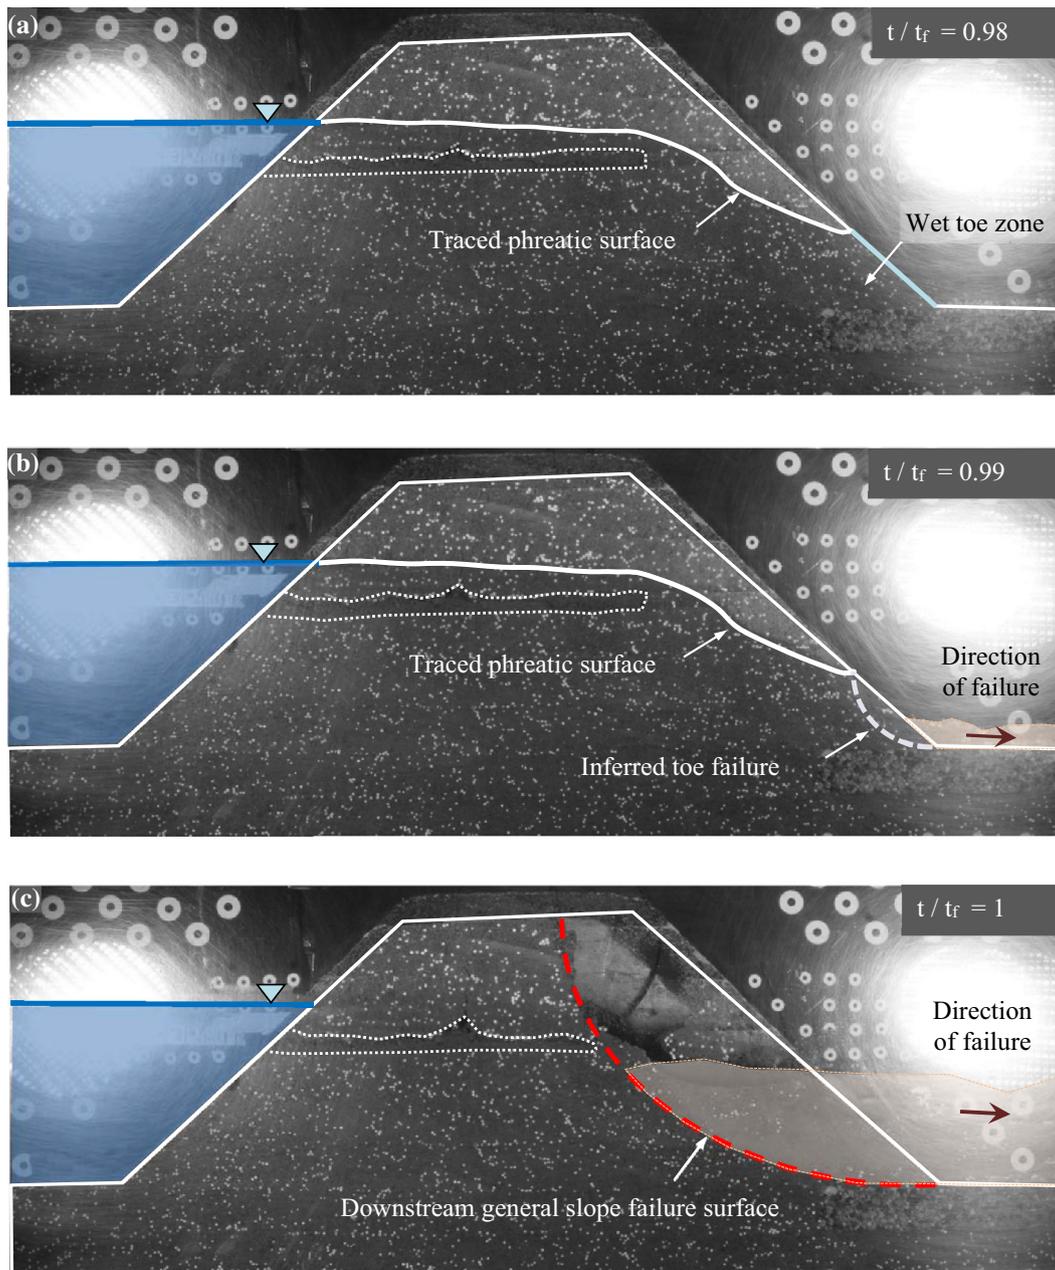
**Fig. 13** Progressive failure of levee with induced midnight burrows: **a** initially stable slope; **b** slope failure at the toe of the levee; **c** extension of the local toe failure to a global slope failure

the local and global failure mechanisms developing in a deteriorated levee for  $t/t_f$  ranging from 0.98 to 1.0. The inferred phreatic surface is overlaid on the profile of the deteriorated levee as schematically shown in Fig. 13a. The noted changes to the default hydraulic response progressively lead to soil piping within the wet zone located above the toe drain, which results in local toe failure as shown in Fig. 13b ( $t/t_f \approx 0.99$ ). As illustrated in Fig. 13c, immediately following the toe failure and with further water seepage and soil erosion, a sudden global failure was developed ( $t/t_f \approx 1$ ). The near circular slope failure started from the levee crest and ended at the toe with a large soil mass moving along with the seeping water toward the landside.
